CALSPAN ON-SITE AIR BAG/CHILD FATALITY INVESTIGATION

CALSPAN CASE NO. 96-16

VEHICLE : 1996 DODGE CARAVAN

LOCATION: FLORIDA

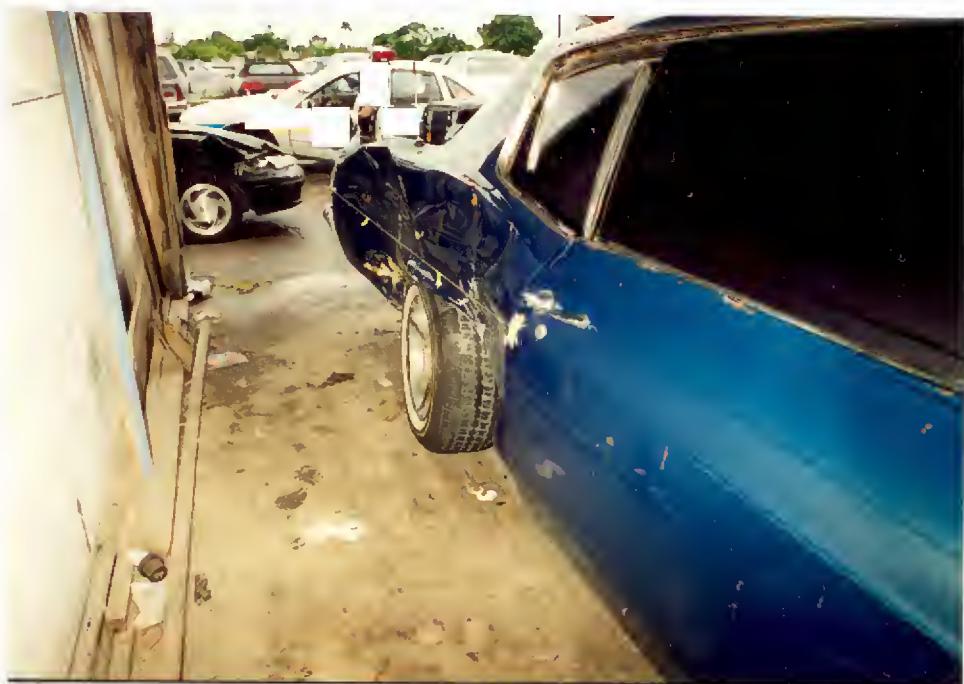
107. View of the impact damage to the Chevrolet Impala.
